Maxwell
Anchormax
Service Manual

Maxwell Anchormax Service

V1 1999 - 2011

V2 2011 to Present

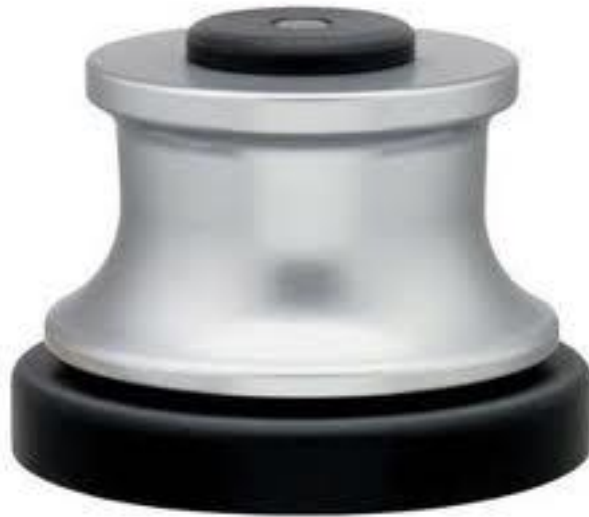
Anchormax V1– Mid 1999 – January 2011

Drum was changed to have the Anchormax logo on top and the bore was increased to Ø44.2 and press in plastic bearings used.

3 x csk screws added to hold the deckplate and baseplate together.

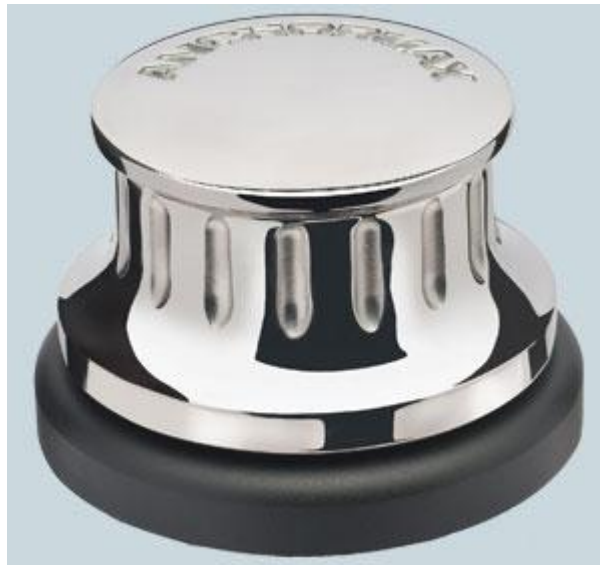
Anchormax V2 – January 2011 to present

Complete redesign, all gears now supported by bearings, stainless steel drum, changed motor from 600W (SP2142) to 500W (SP4189) which due to efficiency increase from bearing changes has same performance.
